**2000 Beneteau 361**

# **Report of Marine Survey**

Conducted by  
John Palcher ABYC, IAMI Certified

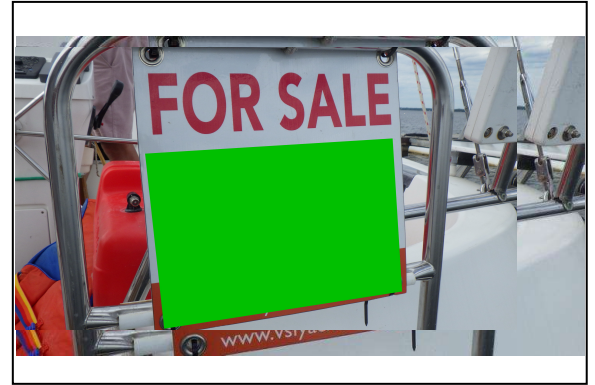
**Broker's Sign**

**Note:** The broker (XXXX YACHT, phone XXX-XXX-XXXX) has a sign that has the wording "Not for sale to US residents while in US waters." The conditions and terms of sale are not a function of this survey. The broker's language should be thoroughly vetted and understood by the buyer.

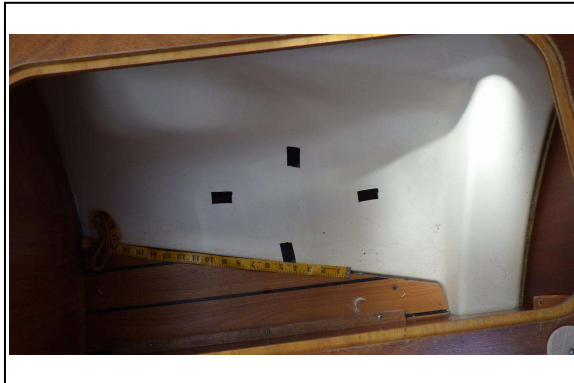
**\*B.1**

The interior port side hull liner is separated in a small area approximately 5" x 8." The area is at the location where the travel lift forward slings are placed. Percussion identified the area, moisture meter readings are not elevated at or around the area.

The interior port side hull liner is separated in a small area approximately 5" x 8."

FINDINGS	RECOMMENDATIONS
The interior port side hull liner is separated in a small area approximately 5" x 8."	Further investigate and repair if necessary, by qualified fiberglass tradesperson.

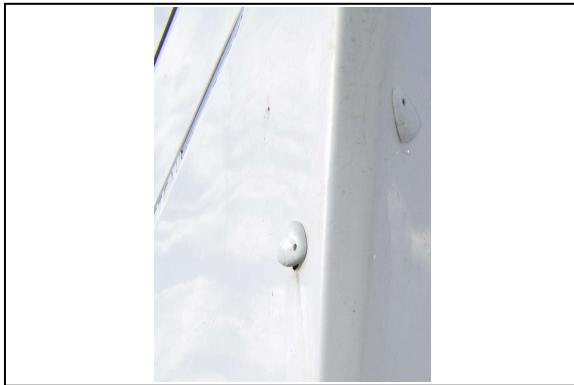
##### **\*C.1**

The starboard side drain cover is out of place.

FINDINGS	RECOMMENDATIONS
<b>The starboard side drain cover is out of place.</b>	<i>Move back in to place.</i>

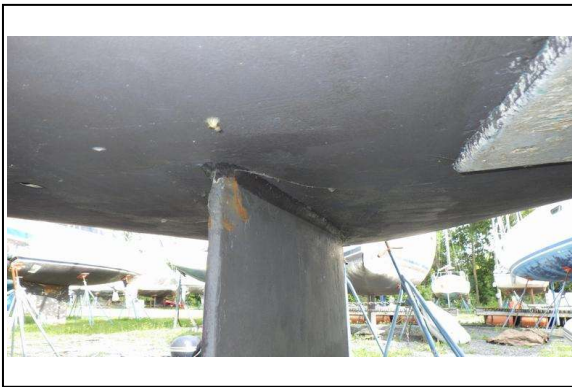
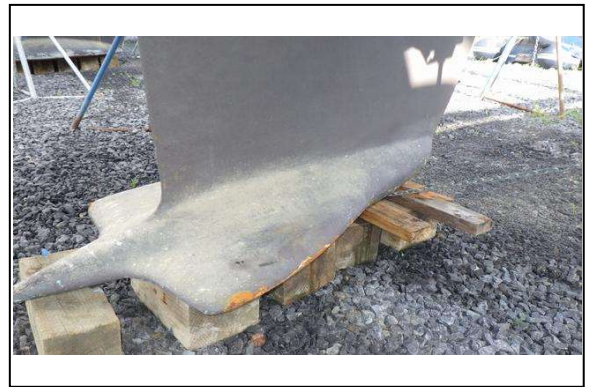
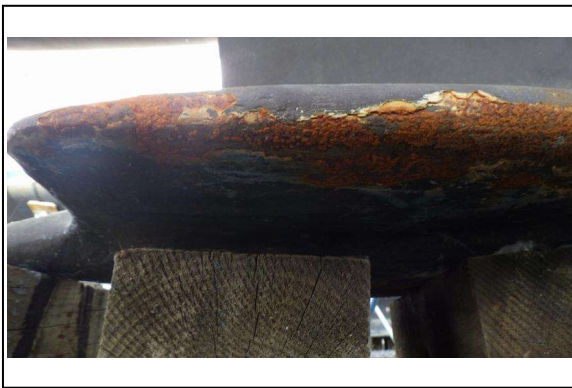
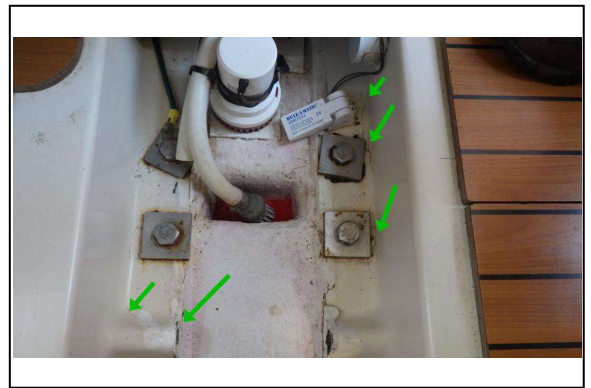
#### \*B.2

The keel is encapsulated in a protective coating. The starboard wing and aft upper areas are corroded. The starboard side wing has a large area of missing coating and subsequent corrosion. The keel bolts were observed while the boat was on the hard and partially sitting on the keel. No evidence of the bolt heads sitting proud was sighted. The keel to hull joint was observed as the boat was lifted, no movement at the joint was observed.

Surrounding some of the keel bolt heads, the liner has stress cracks.

The keel has areas of exposed iron and corrosion. Prior grounding or contact is a possible cause. The hull liner surrounding some of the keel bolts is stress cracked.

FINDINGS	RECOMMENDATIONS
The keel has areas of exposed iron and corrosion. Prior grounding or contact is a possible cause. The hull liner surrounding some of the keel bolts is stress cracked.	-Further investigate and determine the need for repair or adjustment of the keel bolt attachments points. -Remove corrosion and recoat keel.

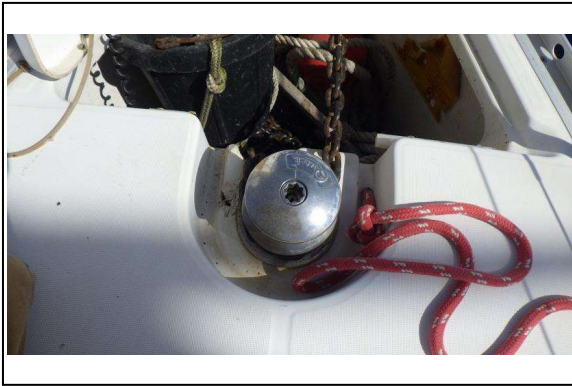
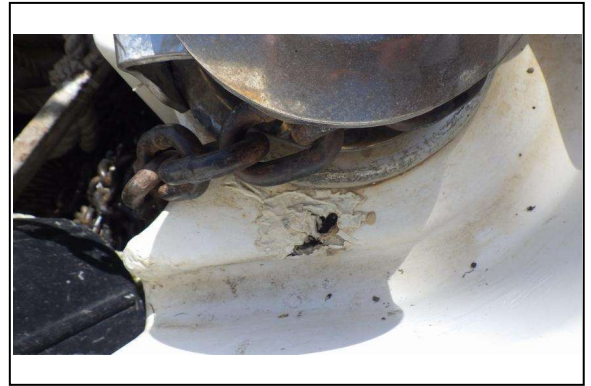
**\*B.3**

The deck incorporates molded non-skid surfaces, appears and feels serviceable. The deck near the windlass has a damaged area in need of repair. No evidence of water infiltration was sighted at the interior underneath the area.

The deck near the windlass has a damaged area in need of repair.

FINDINGS	RECOMMENDATIONS
The deck near the windlass has a damaged area in need of repair.	Repair damage.

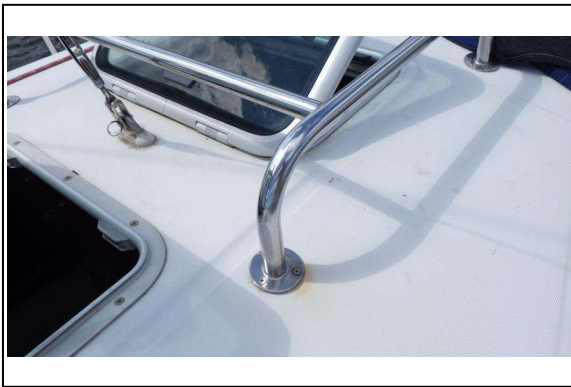
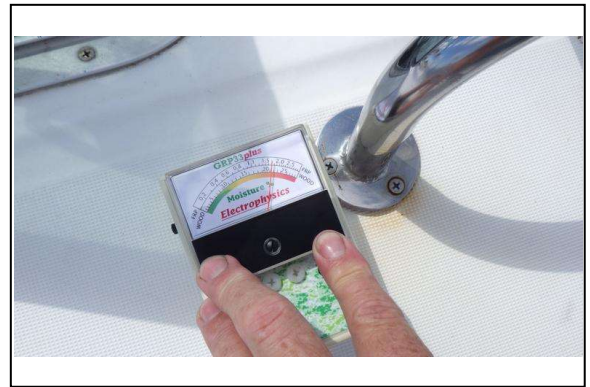
#### **\*B.4**

White gel coat with molded non-skid surfaces. Condition is serviceable. One isolated area of deck about 2" diameter has elevated moisture readings, it is firm under foot and percussion does indicate delamination. This is next to a grab rail base at the starboard side.

One isolated area of deck about 2" diameter has elevated moisture readings.

FINDINGS	RECOMMENDATIONS
One isolated area of deck about 2" diameter has elevated moisture readings.	Rebed grab handle.

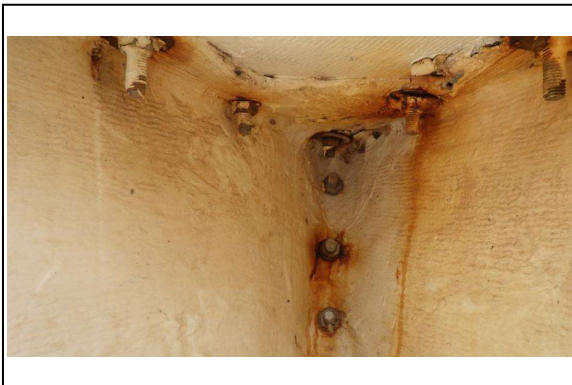
#### **\*B.5**

Signs of water intrusion noted at bow under chain locker.

Signs of water intrusion noted at bow under chain locker. Corrosion at bolts.

FINDINGS	RECOMMENDATIONS
Signs of water intrusion noted at bow under chain locker. Corrosion at bolts.	Further investigate and repair as necessary.

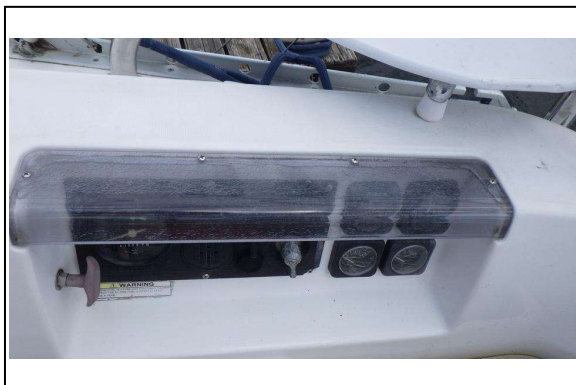
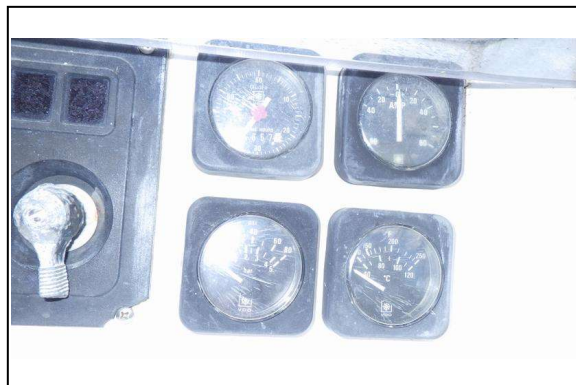
Helm cockpit engine gauges are difficult to read due to UV damaged and crazed lenses. The DCV meter does not appear to work.

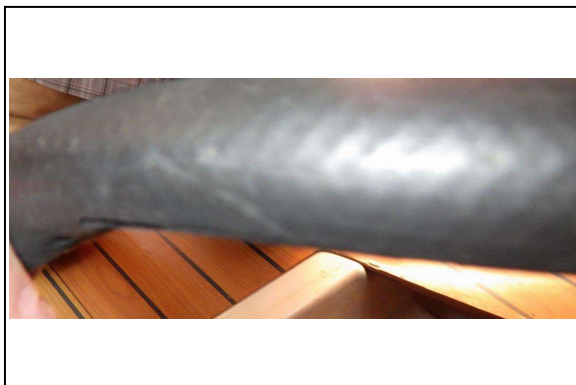
**Damaged Hose**

Engine water hose at cooling pump is damaged, possibly due to contact with alternator blades. Not leaking during inspection.

Engine water hose at cooling pump is damaged.

FINDINGS	RECOMMENDATIONS
Engine water hose at cooling pump is damaged.	Replace hose. Secure to prevent damage.

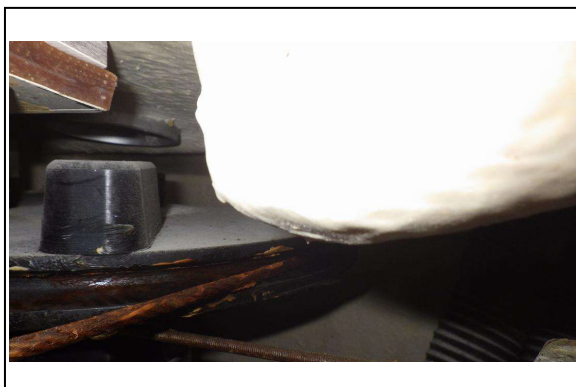
**\*B.12**

TYPE:  
Pedestal with wheel and cables. Cables have corrosion and are slack.

Cables have corrosion and are slack.

FINDINGS	RECOMMENDATIONS
<b>Cables have corrosion and are slack.</b>	<i>Investigate further. Repair or replace as necessary. Full service by an expert.</i>

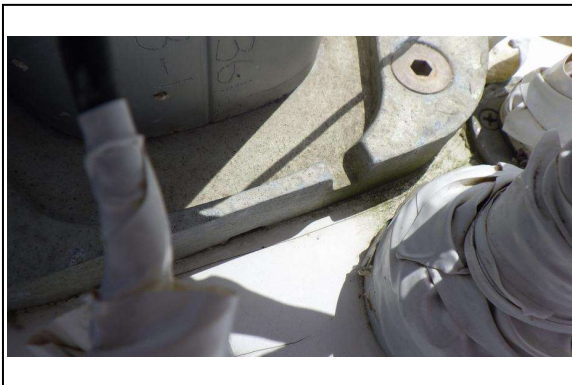
**Mast Step**

Mast step, fine gel coat stress crack sighted. No obvious deflection of deck. Compression post is stainless steel and its attachment at the keel has no cracking or deflection.

Mast step, fine gel coat stress crack sighted

FINDINGS	RECOMMENDATIONS
Mast step, fine gel coat stress crack sighted	Monitor for development of deflection at deck.

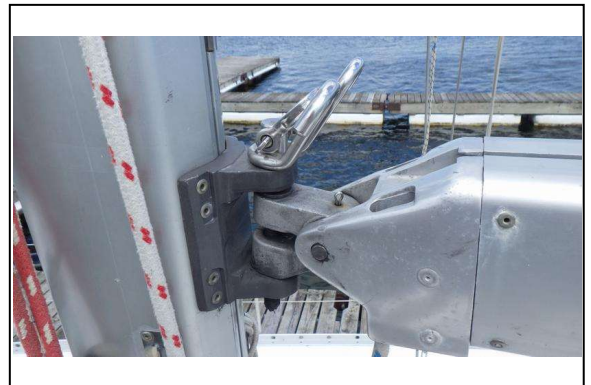
**Improper Sized Pin**

Aluminum boom. Appeared serviceable. The boom to mast connection utilizes a cotter pin to hold the assembly in place, the pin is undersized and not properly attached. One pulley has a missing rivet head.

The boom to mast connection utilizes a cotter pin to hold the assembly in place, the pin is undersized and not properly attached. One pulley has a missing rivet head.

FINDINGS	RECOMMENDATIONS
<b>The boom to mast connection utilizes a cotter pin to hold the assembly in place, the pin is undersized and not properly attached. One pulley has a missing rivet head.</b>	<i>Repair pulley attachment rivet and replace cotter pin with correct sized pin.</i>

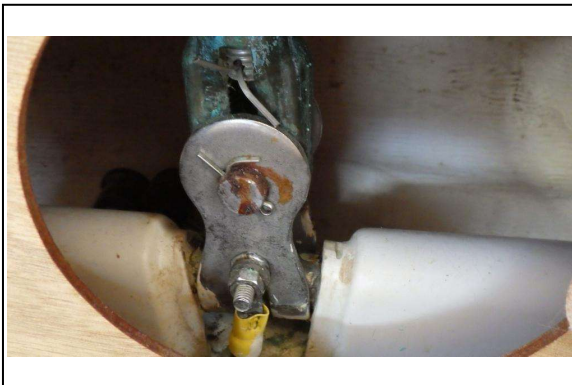
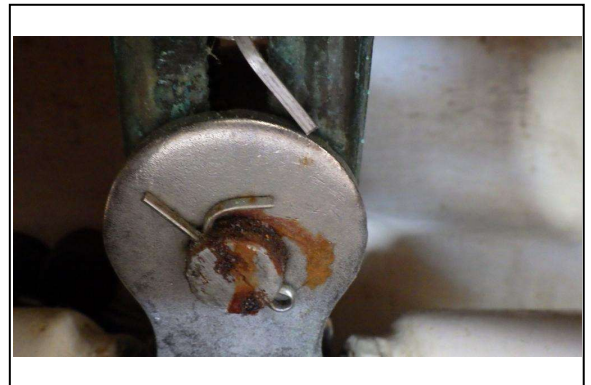
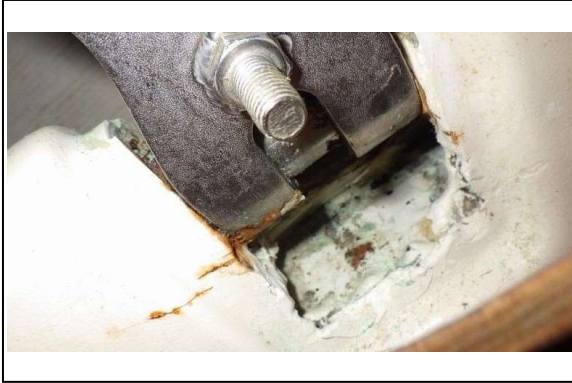
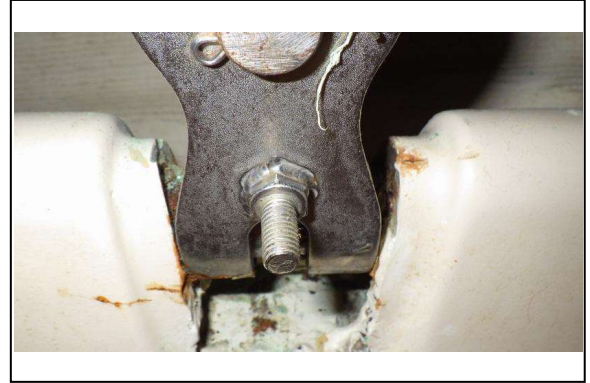
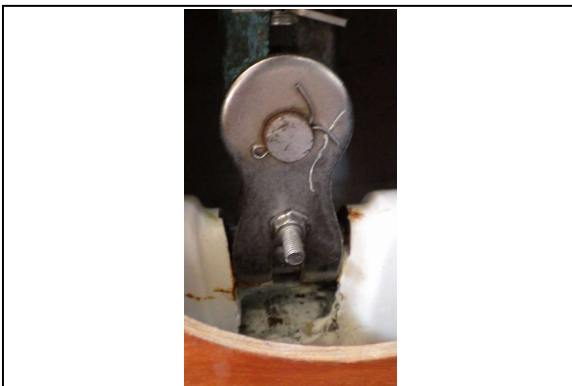
Midship stay anchor connections are corroded at port and starboard. Corrosion sighted at some shrouds.

FINDINGS	RECOMMENDATIONS
Midship stay anchor connections are corroded at port and starboard. Corrosion sighted at some shrouds.	Repair/replace midship stay anchor point hardware. Close inspection of all standing rigging by qualified rigger recommended.
