**PALCHER MARINE CONSULTANTS, INC.**  
MARINE SURVEYOR AND CONSULTANT

**1998 Donzi 3250 LXC**

## Report of Marine Survey

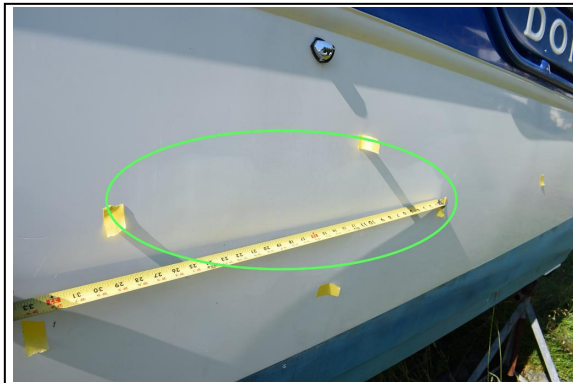
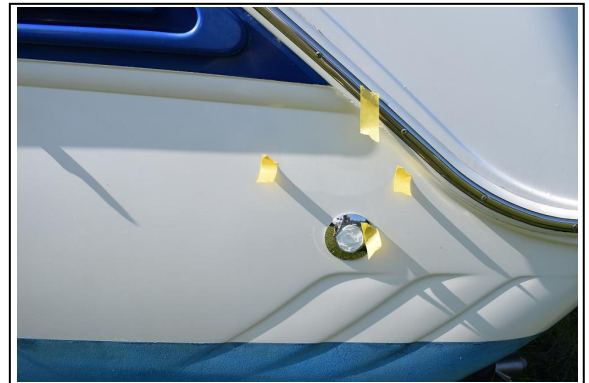
- Gel Coat repair areas visible at port side.
- Some scrapes in plastic areas of rub rail.
- One full thickness gel coat gouge, port side.
- Some partial thickness gel coat scrapes.

**Gel Coat Repair Area**

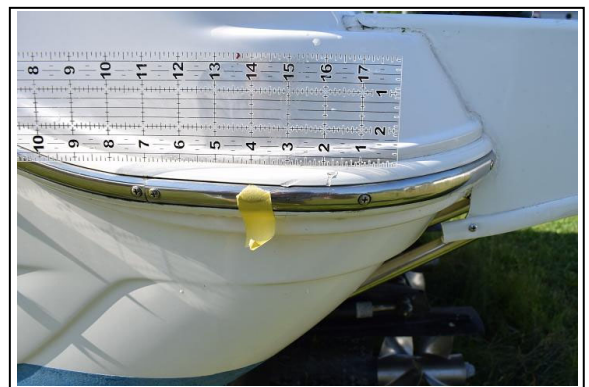
**Rub Rail Damage**

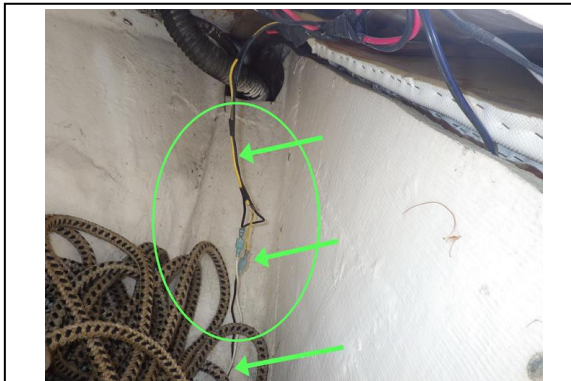
**\*A3**

Electrical cables at anchor locker are subject to damage from rode.

**Electrical Cables**

FINDINGS	RECOMMENDATIONS
<b>Electrical cables at anchor locker are subject to damage from rode.</b>	<i>Secure cables away from rode and stored equipment.</i>

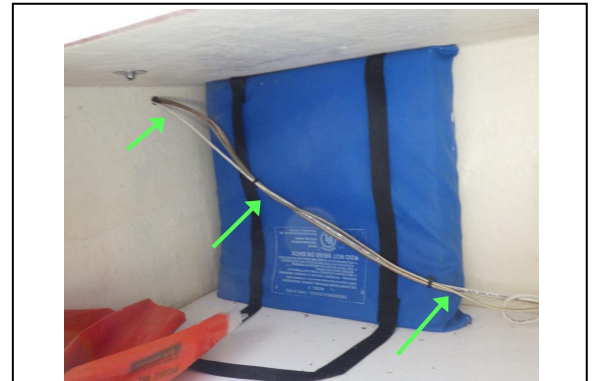
Electrical cables at anchor locker and under helm seat are subject to damage from stored equipment and anchor rode.

**Under Helm Seat**

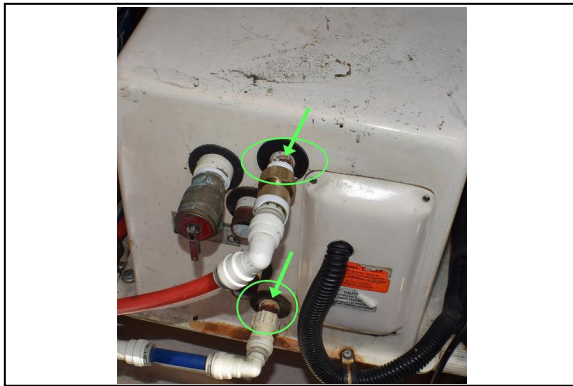
**\*B.6**

- Evidence of previous leaking.
- Corroded fittings.

Water heater has corroded fittings.

**Corroded Fittings**

FINDINGS	RECOMMENDATIONS
Water heater has corroded fittings.	Monitor condition, repair as needed.

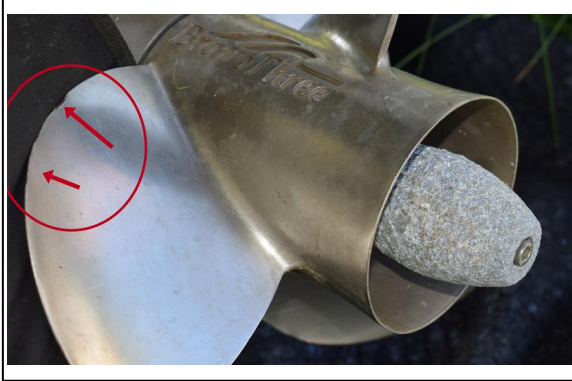
**Starboard aft prop has some edge damage, still serviceable condition.**

**Prop Blade Damage**

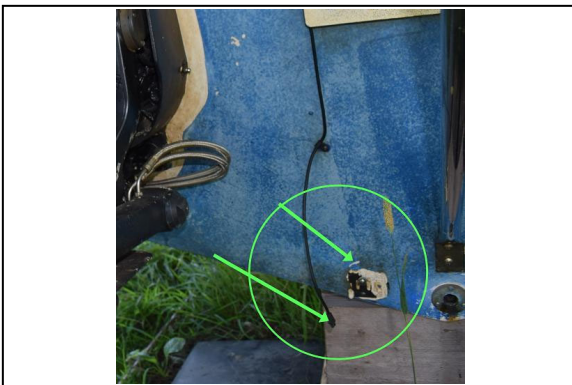
#### **\*B.10**

One is damaged.

Transom mounted transducer is damaged.

**Damaged Transducer**

FINDINGS	RECOMMENDATIONS
Transom mounted transducer is damaged.	Investigate further and repair or renew as necessary.

**Investigate further and repair or renew as necessary.**
