PALCHER MARINE CONSULTANTS, INC.
MARINE SURVEYOR AND CONSULTANT

1999 Hacker Triple

Report of Marine Survey

May 26, 2020

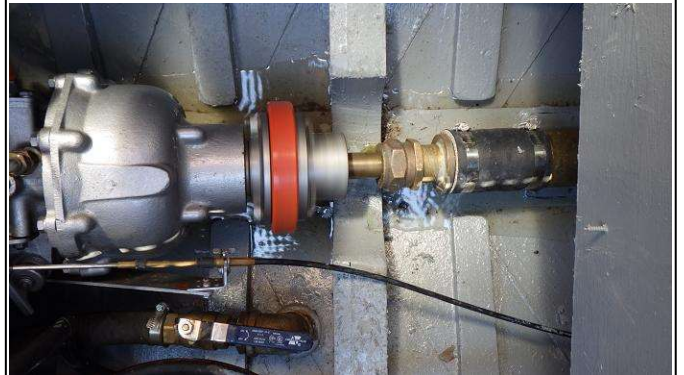
Drive Train

Excessive engine vibration occurs at about 2600 rpm.

The significant vibration of the drive train needs to be identified and corrected. The cause of the vibration may be an easily corrected issue, such as a shaft or coupler alignment issue. Whatever the correction, the details of any and all work needed to fix the problem should be specifically documented, and verified.

FINDINGS	RECOMMENDATIONS
Excessive engine vibration occurs at about 2600 rpm.	<i>Determine the source and cause of vibration and correct.</i>

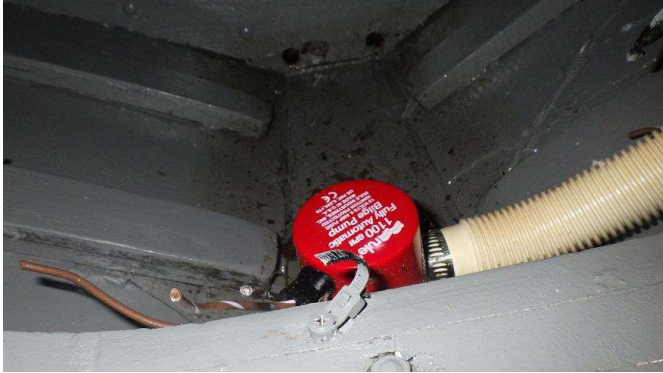
Bilge Pump

One bilge pump was mounted in the boat midship. The pump did not work.

The bilge pump did not work.

- The bilge pump was not connected to the 12 vdc power system, it did not work.
- The port side fuel line is in close to the shift linkage. A potential exists for contact wear.

FINDINGS	RECOMMENDATIONS
The bilge pump did not work.	<i>Repair bilge pump.</i>

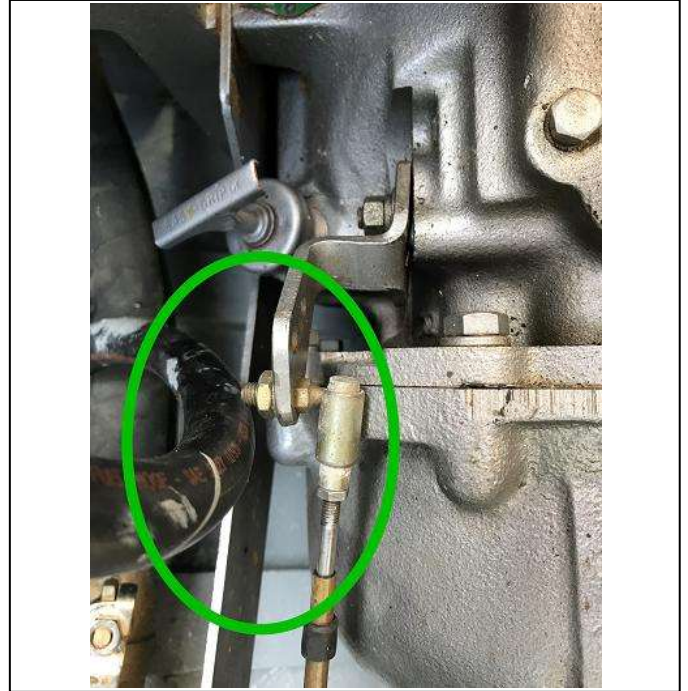
Fuel Hose Near Transmission Linkage

The port side fuel line is in close to the shift linkage. A potential exists for contact wear.

FINDINGS	RECOMMENDATIONS
The port side fuel line is in close to the shift linkage. A potential exists for contact wear.	Secure fuel line to avoid potential contact.
