# **PALCHER MARINE CONSULTANTS, INC.**

## **1998 Donzi 3250 LXC**

## **Report of Marine Survey**

07-25-2022

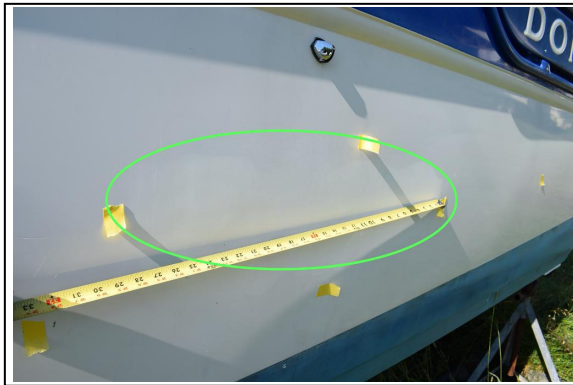
- Percussion and moisture meter readings do not identify evidence of elevated moisture or de lamination.
- Gel Coat repair areas visible at port side.
- Some scrapes in plastic areas of rub rail.
- One full thickness gel coat gouge, port side.
- Some partial thickness gel coat scrapes.

**Gel Coat Repair Area**

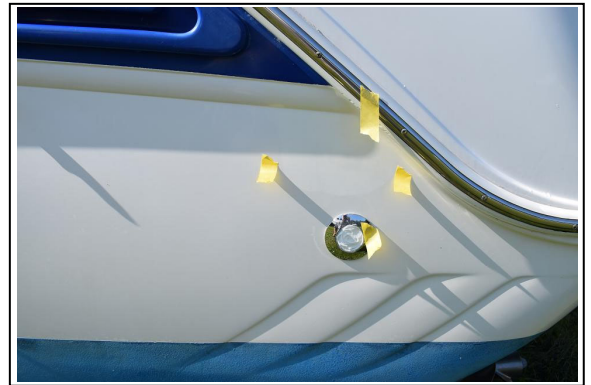
**Gel Coat Repair Area**

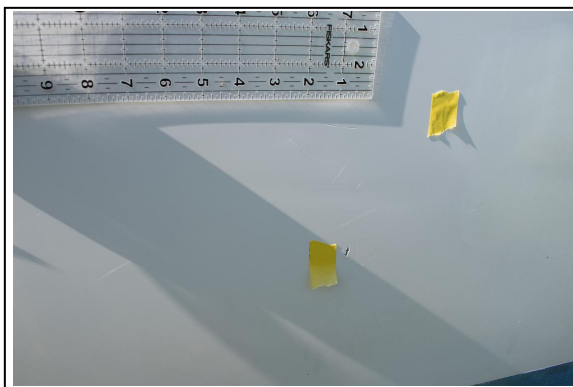
**Gel Coat Damage**

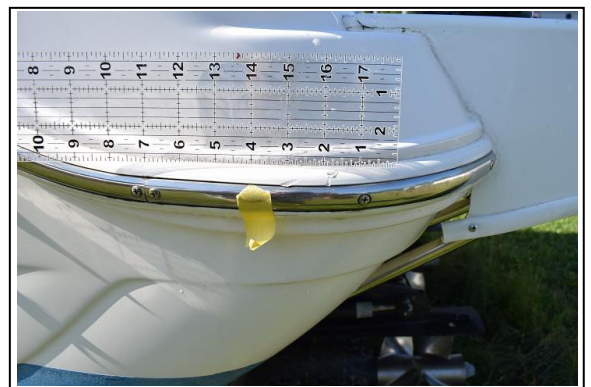
**Rub Rail Damage**

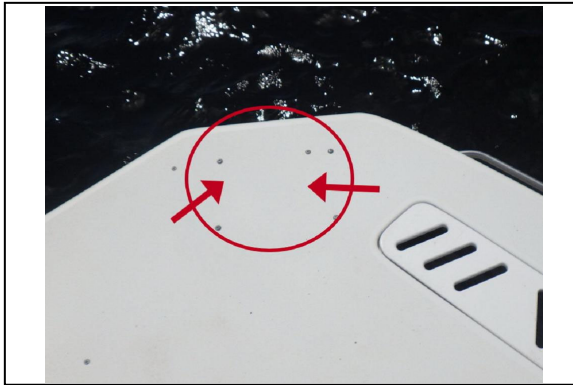
#### **\*B.2**

Swim platform near ladder hardware has some elevated moisture readings.  
Area is firm under foot, percussion does not indicate de lamination.

Swim platform near ladder hardware has some elevated moisture readings.

**Elevated Moisture**

FINDINGS	RECOMMENDATIONS
Swim platform near ladder hardware has some elevated moisture readings.	Monitor condition, consider re-bedding ladder hardware.

**Monitor condition, consider re-bedding ladder hardware.**

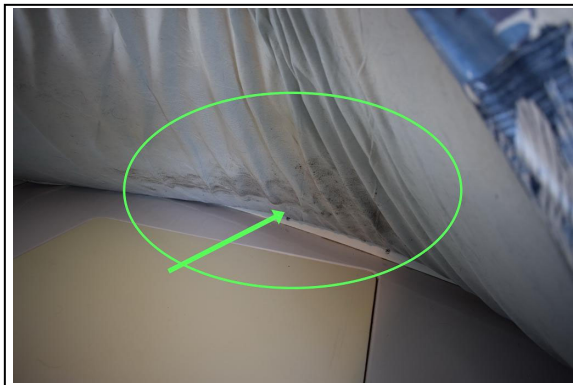
**Underside of forward berth cushion has some mildew.  
Area dry during inspection.**

**Mildewed Cushion**

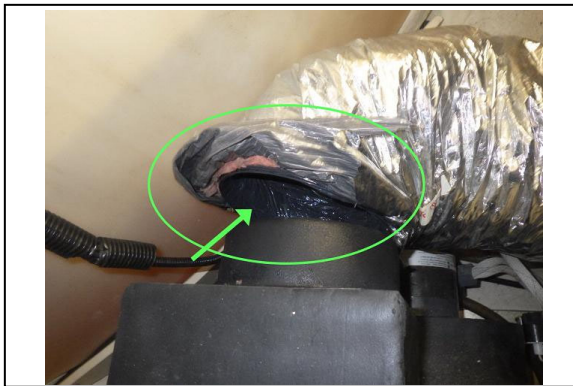
**-Main discharge duct loose and easily slides off.**

**-Aft berth duct has no detectable air discharge.**

**-AC Unit uses R22 refrigerant, and may be costly to recharge and or repair.**

**AC Duct**

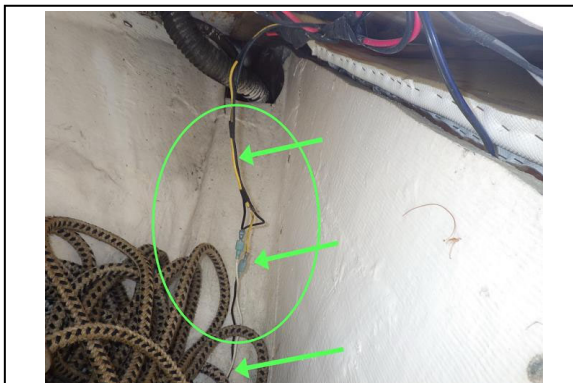
#### **\*A3**

Electrical cables at anchor locker and under helm seat are subject to damage from stored equipment and anchor rode.

Electrical cables at anchor locker are subject to damage from rode.

**Electrical Cables**

FINDINGS	RECOMMENDATIONS
Electrical cables at anchor locker are subject to damage from rode.	Secure cables away from rode and stored equipment.

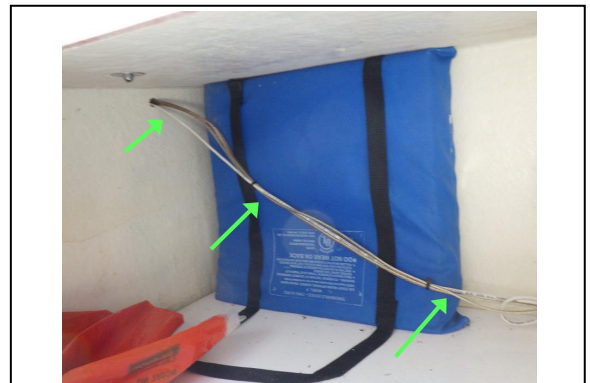
**Under Helm Seat**

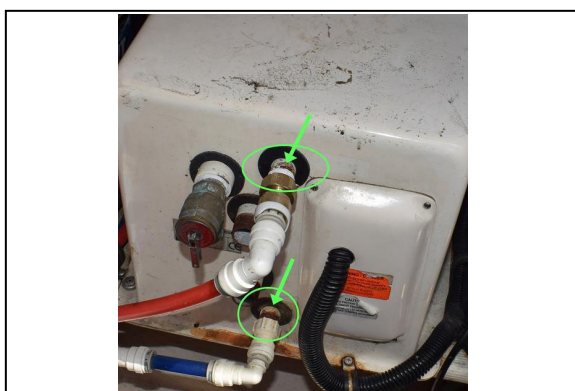
**\*B.6**

- Evidence of previous leaking.
- Corroded fittings.

Water heater has corroded fittings.

**Corroded Fittings**

FINDINGS	RECOMMENDATIONS
Water heater has corroded fittings.	Monitor condition, repair as needed.

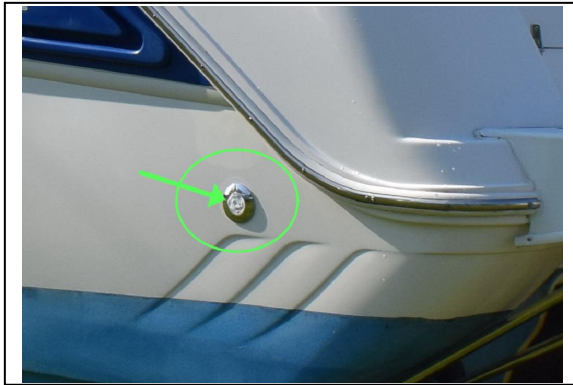
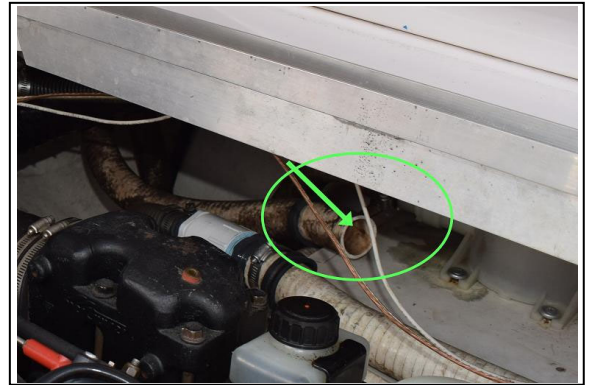
#### \*A6

Tank to overboard discharge has been disconnected.

**Discharge Thru Hull**

**Hose Connected To Thru Hull**

FINDINGS	RECOMMENDATIONS
<b>Tank to overboard discharge has been disconnected.</b>	<i>Hose should have a plugged end as a precaution against water intrusion.</i>

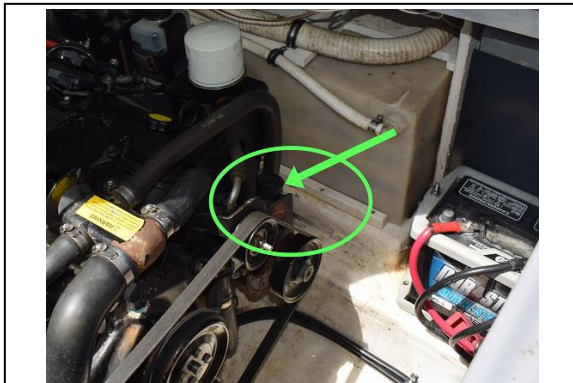
**\*B.7**  
Port power steering pump fluid level below dipstick.

**Port Power Steering Pump**

FINDINGS	RECOMMENDATIONS
Port power steering pump fluid level below dipstick.	Further investigate and fill to manufacturer recommended capacity.

**Further investigate and fill to manufacturer recommended capacity.**

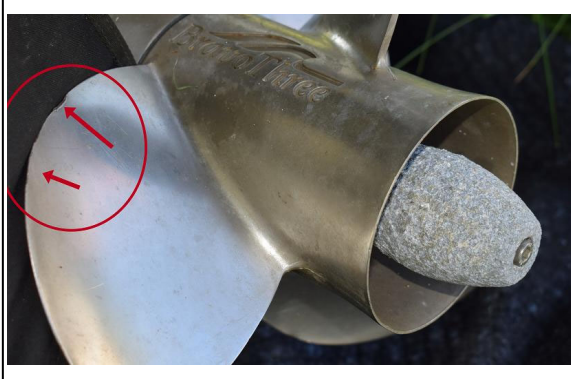
**Starboard aft prop has some edge damage, still serviceable condition.**

**Prop Blade Damage**

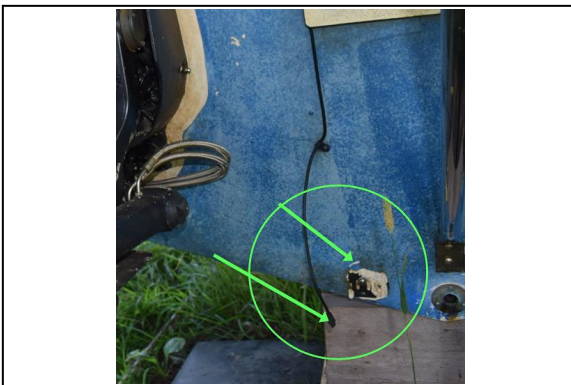
#### **\*B.10**

One is damaged.

Transom mounted transducer is damaged.

**Damaged Transducer**

FINDINGS	RECOMMENDATIONS
Transom mounted transducer is damaged.	Investigate further and repair or renew as necessary.

**Investigate further and repair or renew as necessary.**

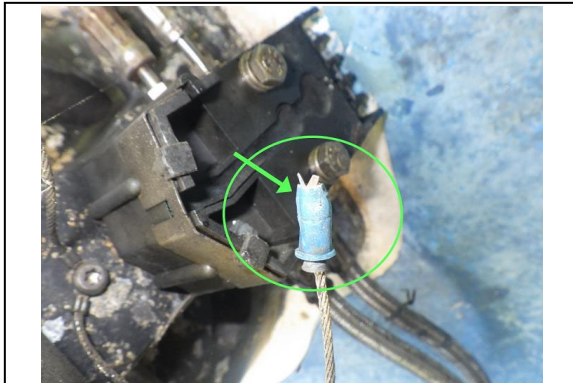
Some surface corrosion on skegs.

Port side tilt trim lines are worn.

**Disconnected Bonding Cable**

FINDINGS	RECOMMENDATIONS
Starboard outdrive has a disconnected bonding cable. Some surface corrosion on skegs. Port side tilt trim lines are worn.	Further investigate and repair as necessary. Clean and coat outdrive surfaces.

**Further investigate and repair as necessary. Clean and coat outdrive surfaces.**
