2006 Beneteau 343

Report of Marine Survey

Conducted by
John Palcher

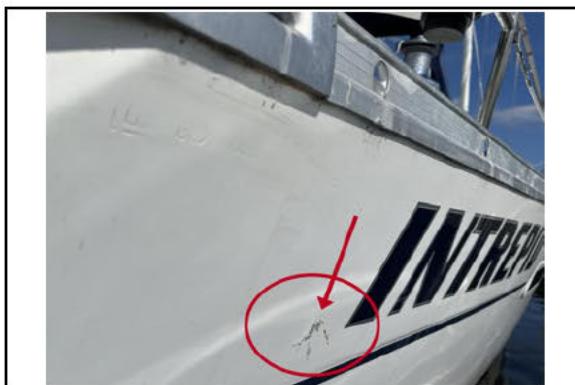
Starboard Scratch

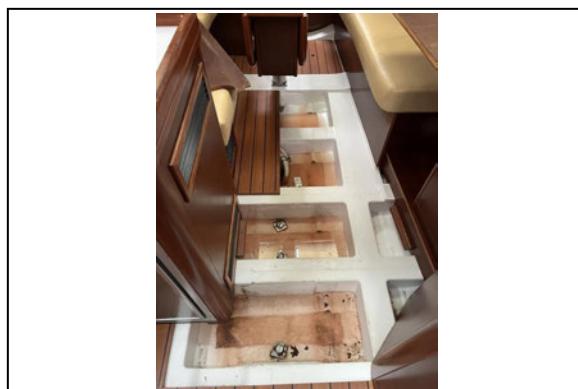
Some clear water in bilge.

Bilge Water

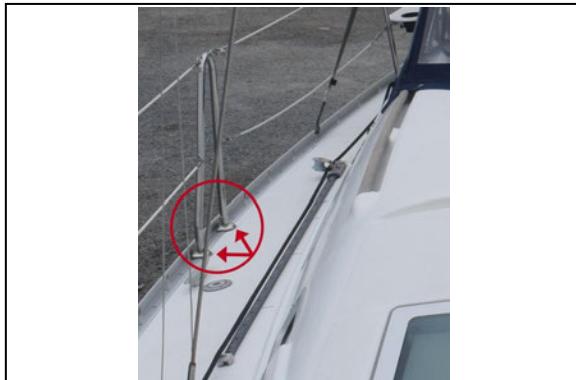
One area has elevated moisture readings.

One area of the deck has elevated moisture readings.

Elevated Moisture

FINDINGS	RECOMMENDATIONS
One area of the deck has elevated moisture readings.	<i>Consider re bedding deck hardware at this area to prevent water intrusion.</i>

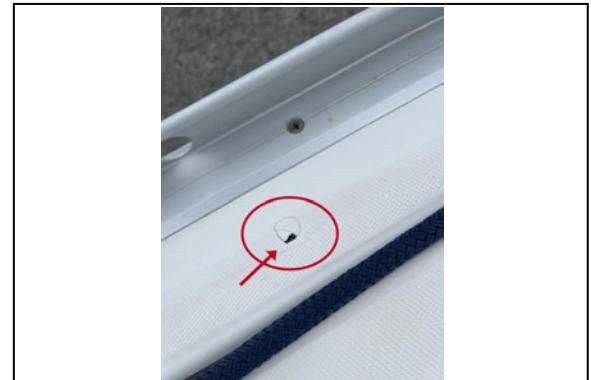
- Firm under foot, sound with percussion.
- Small gel coat chip at port forward deck.
- Some fine gel coat cracks visible.

Chip

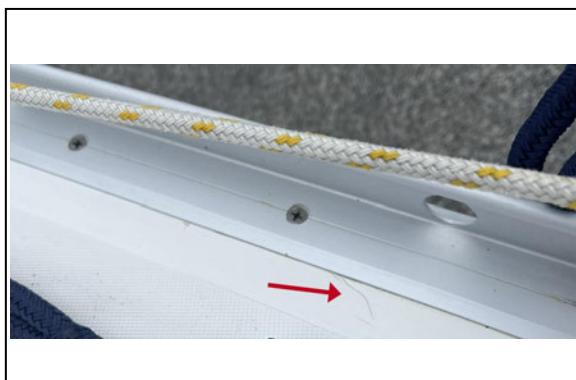
Crack (typical)

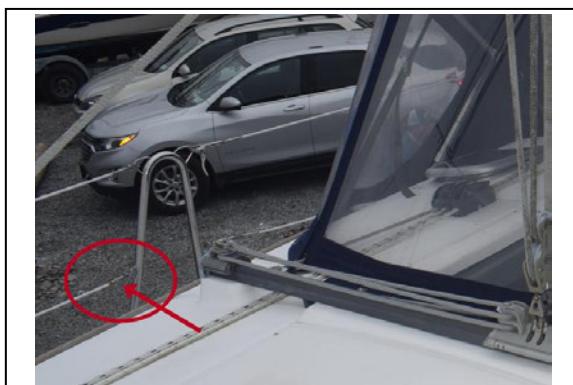
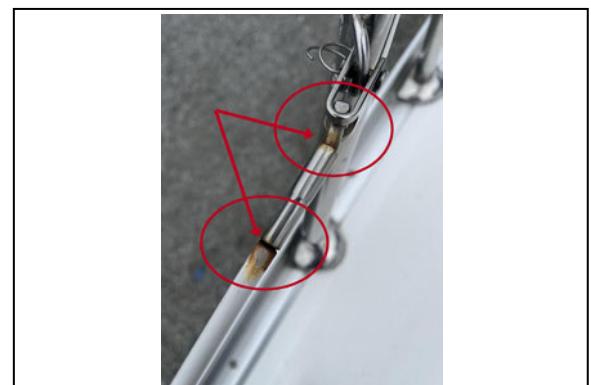
***A.1**

**Corrosion and potential damage at lower lifeline connection.
Starboard side.**

Corrosion and potential damage at lower lifeline connection.

Lifeline

Corrosion-Damage

Investigate further for needed repair/replacement.

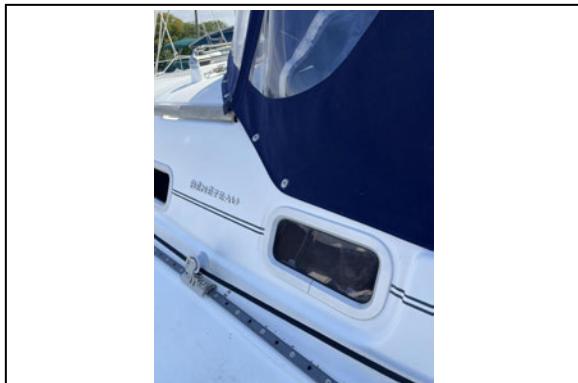
Some portlights have crazing.

Crazing

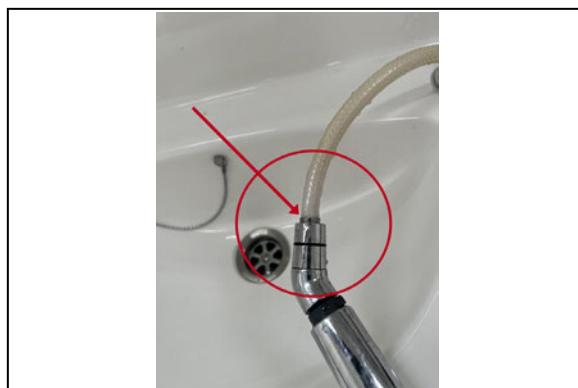
***B.2**

Head faucet has leak at base of fixture.

Further investigate and repair as necessary.

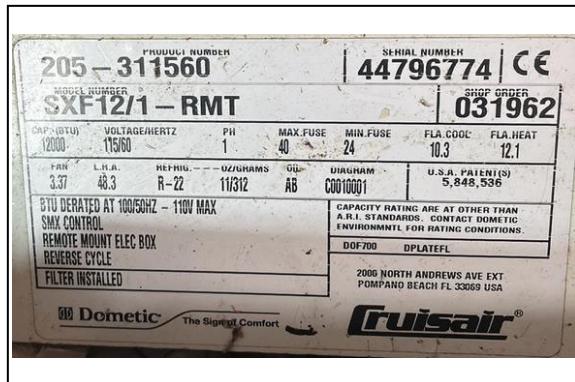
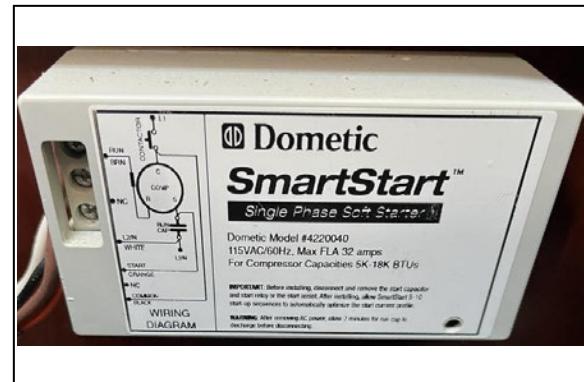
*C.2

AC Unit uses R22 refrigerant, and may be costly to recharge and or repair.

AC Unit uses R22 refrigerant.

AC Unit Label

AC Unit Start Control

FINDINGS	RECOMMENDATIONS
AC Unit uses R22 refrigerant.	<i>This may be costly to recharge and or repair.</i>

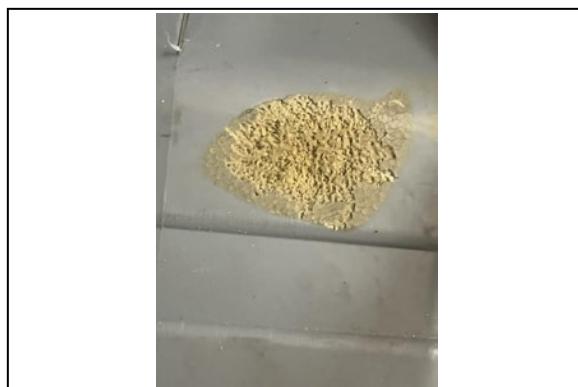
*A.2

No visible leaking.

Muffler has an area of wear similar to a corrosive material contacting it.

Muffler Wear

FINDINGS	RECOMMENDATIONS
Muffler has an area of wear similar to a corrosive material contacting it.	<i>Investigate further and repair or renew as necessary.</i>

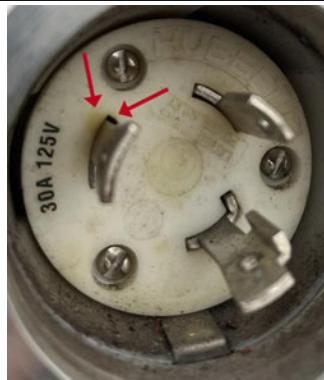
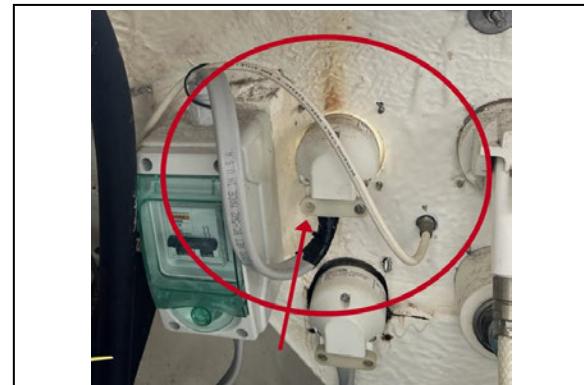
Lower inlet has indications of heating.

Upper inlet has missing cable hold hardware.

Heating

Investigate further and repair or renew as necessary.

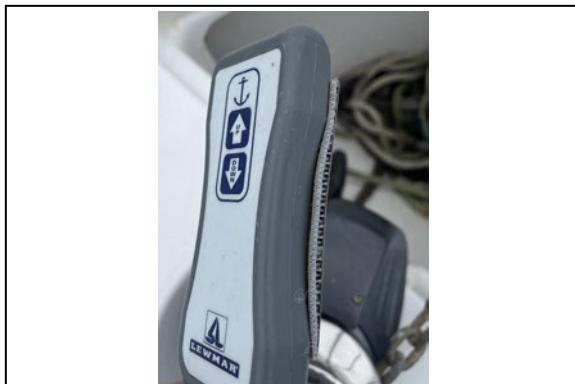
*B.5

Windlass bow controller is not properly mounted.

Further investigate and repair / remount.

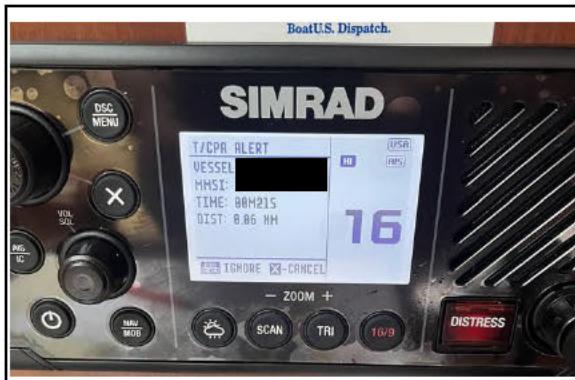
*B.6

MMSI information not current with vessel.

FINDINGS	RECOMMENDATIONS
MMSI information not current with vessel.	<i>Properly register VHF MMSI information.</i>

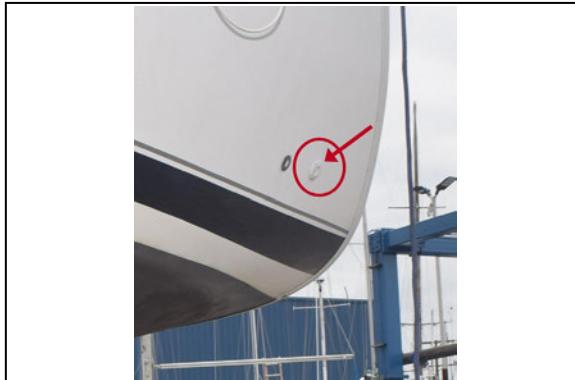
***B.9**

It is UV damaged and worn.

Plastic port aft above water thru hull is worn.

Consider replacement.

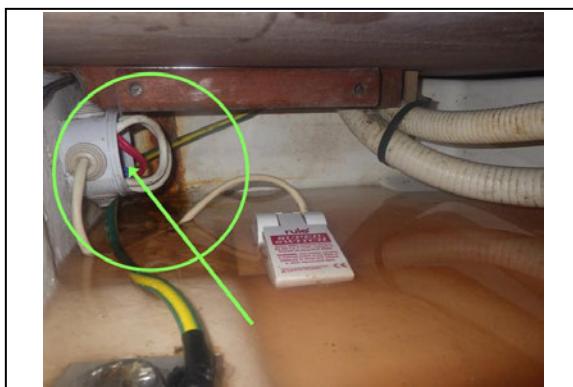
*A.7

**Bilge pump powers up, but water does not properly discharge.
Wet location box has missing cover.**

- Electric bilge pump system is not operable.
- Manual pump not functionally tested.
- Wet location box has missing cover.

Missing Cover

Investigate further and repair or renew as necessary.

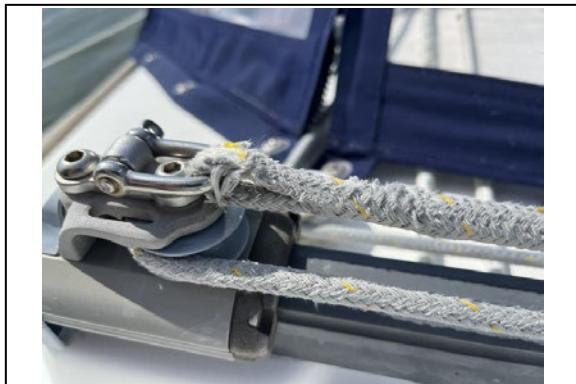
- Mostly good condition.
- Wear visible on main sheet traveler.**

Wear
